Manhole Inspection Summary

Manhole # S25AA1005MH

Insp Date: **1/30/07 9:48 AM**

Location Address: **3555 BUENA VISTA AVE**

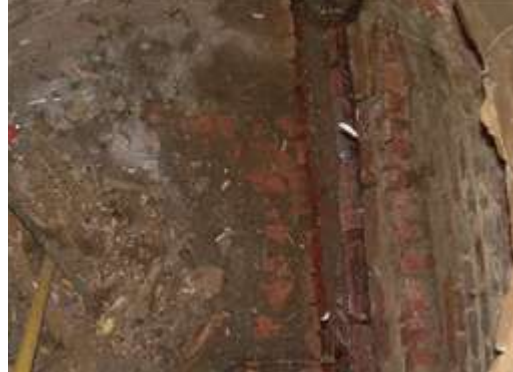
Top View

Bench debris.

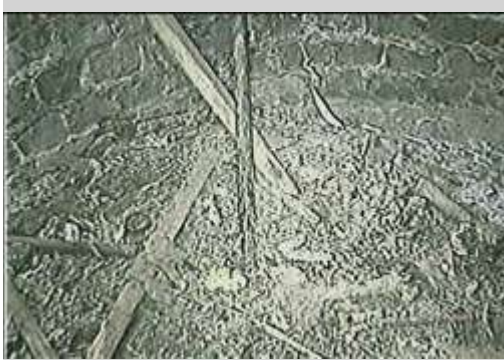
Defect

Barrel deterioration and infiltration.

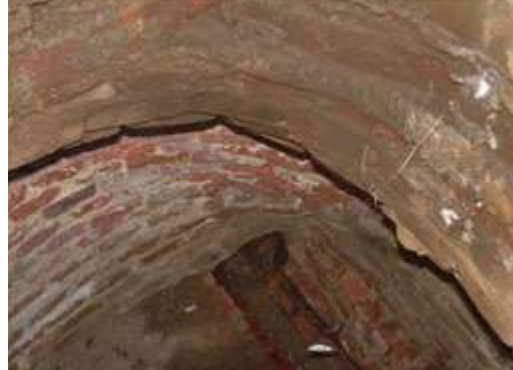
Defect

Frame leaks. Adjustment deterioration and infiltration. Barrel infiltration.

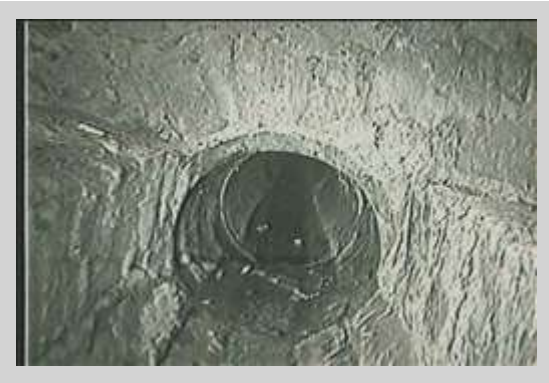
8 in. Circular Gravity Sewer Pipe Out @ 12 O'Clock

Barrel deterioration and infiltration.

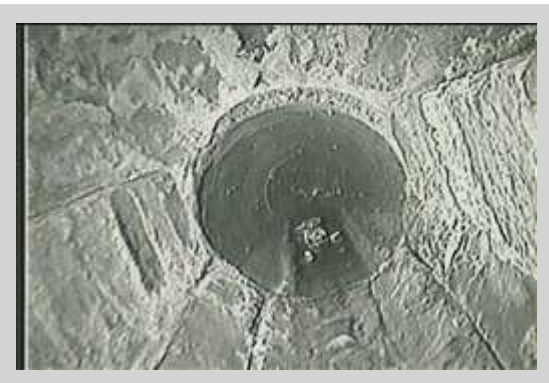
8 in. Circular Gravity Sewer Pipe In @ 6 O'Clock

Channel deterioration.
